Clay Layer Separation Detection in Potash Mines using Stepped Frequency Radar Technology

Abstract

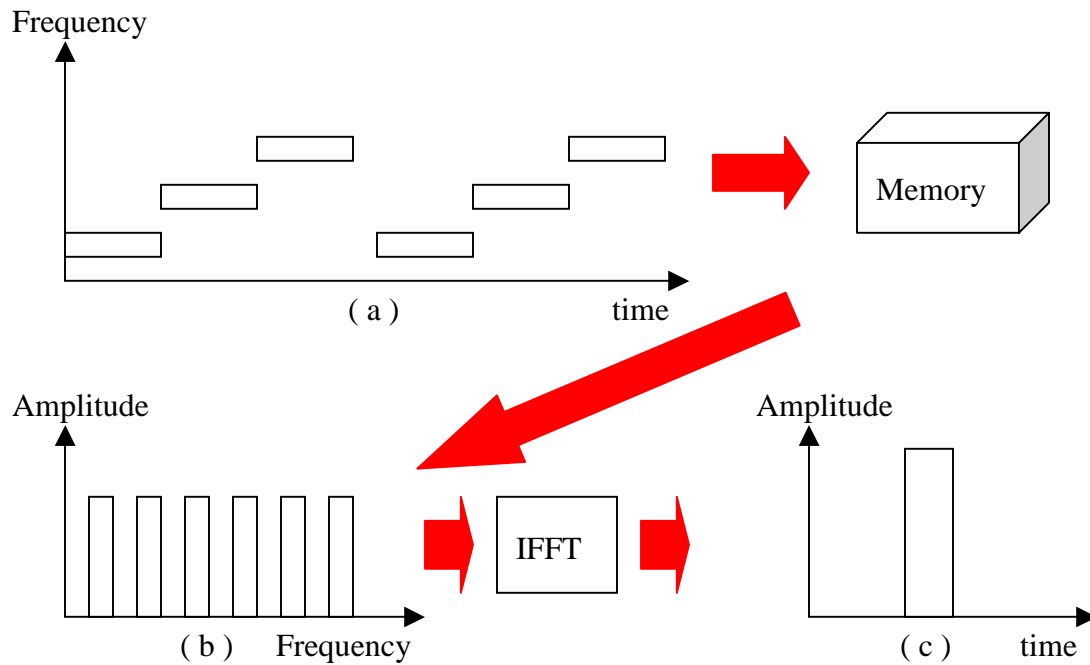
Figure 1: Stepped frequency radar operation. (a) Measurement of echoes at single frequency lines, (b) compiled receive spectrum and (c) synthesised pulse. (after Valle et al., 2000)

In contrast to classical pulse radar systems, stepped frequency radar systems such as CRIS operate with amplitude-continuous radar signals. The signal bandwidth required for the desired radar resolution is generated sequentially in discrete steps through the desired frequency range. In the receiver section, both phase and amplitude measurements of the return signals are performed. The resulting data is then IFFT (Inverse Fast Fourier Transform) processed to generate a synthesized pulse (Figure 1; Valle et al., 2000).

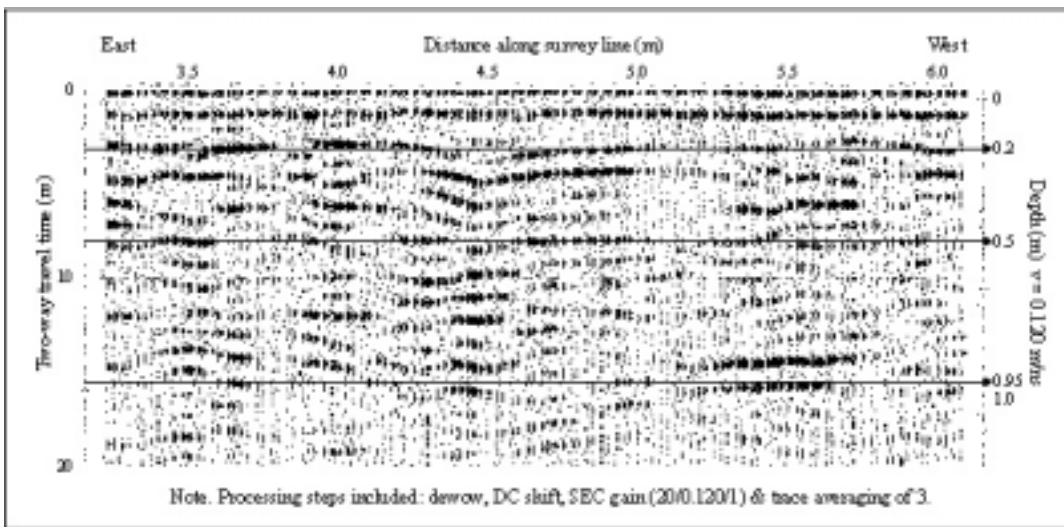
Figure 3: Radargram of rock cut obtained using 1000 MHz pulse radar system (Wilchek, 2000).

Wilchek (2000) evaluated the fracture detection capabilities of conventional pulse radar systems in hardrock environments around Sudbury. These same sites were used to evaluate the performance of CRIS. At one site (Hwy. 17 Bypass) the rock structure was clearly defined (Figure 2). Two fractures were visible behind the face of the rock cut, one at a depth of 20 cm and the other at a depth of 50 cm. Figure 3 presents the radar data obtained by Wilchek (2000) using the 1000 MHz pulse system. The fracture locations, indicated by the solid lines, are not immediately apparent, particularly to the untrained eye, because of multiple reflections and noise. A scan of a portion of the same rock cut using the CRIS radar is presented in Figure 4. The two fractures are easily identified in the image (Note: the weaker reflection at 35 cm is clearly an artefact as the reflected energy is lower than that from the deeper feature). The detection capability and the ease of interpretation offered by CRIS were the key factors in enticing the potash industry to pursue the technology further.

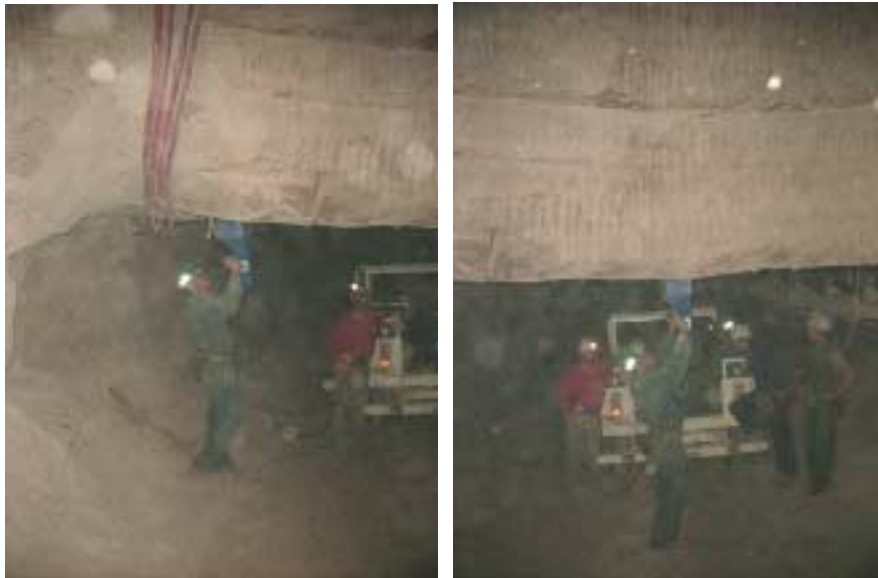
Figure 5: Hand scanning of brow along 13 Conveyor Drift at Lanigan Mine.

The following select examples demonstrate the ability of CRIS to detect bed separation features in the back of drifts mechanically excavated in potash. Photos showing the typical field operation of the CRIS unit are shown in Figure 5.

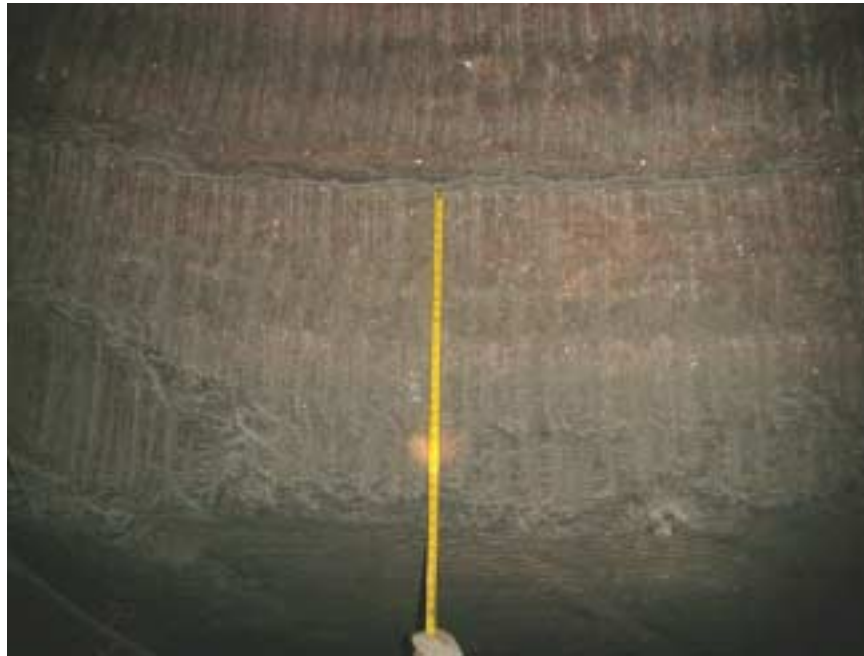
Figure 7: Photo of observed fracture in brow along Main 5 access drift.

A brow along the Main 5 access drift with a visible fracture was selected as an ideal test location. The scan proceeded along the axis of the drift from 1 m in front of the brow to 6 m past it (Figure 6). Figure 7 is a photo of the observed fracture.

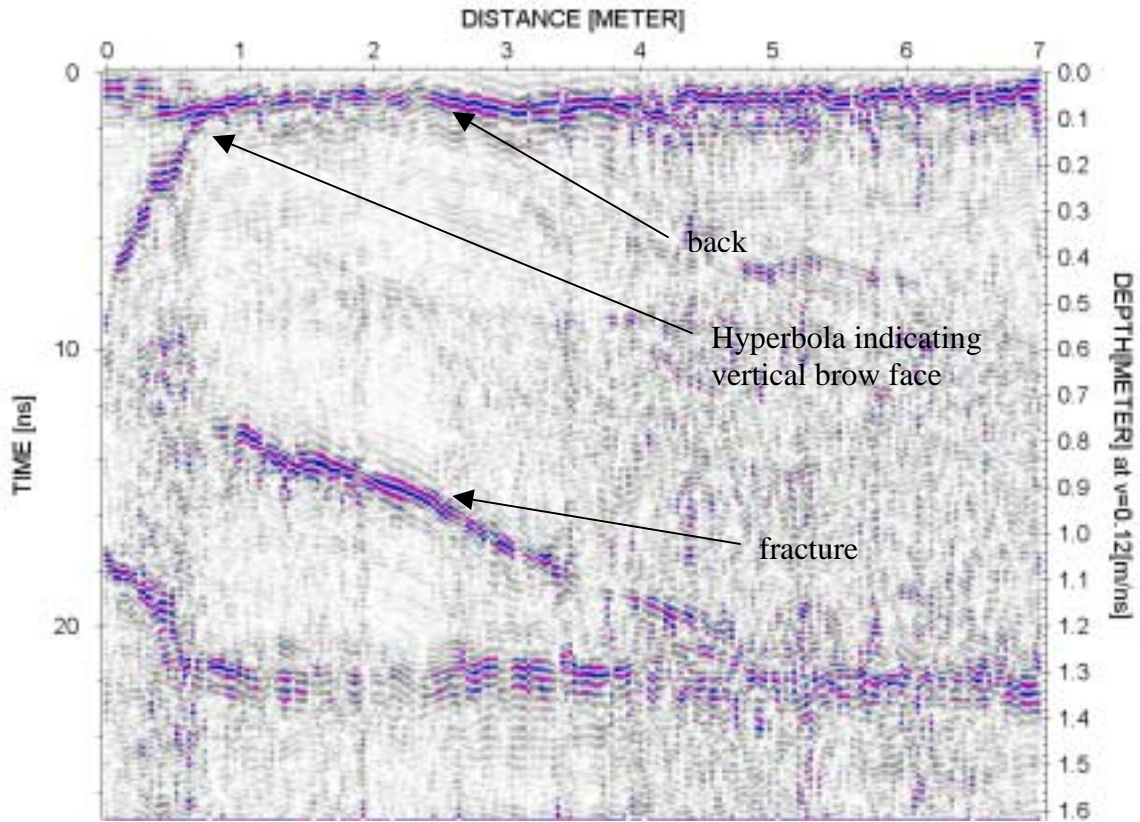
Figure 8: Longitudinal profile of brow in Main 5 access drift showing fracture in brow.

Figure 8 shows the results of the radar scan. A hyperbola indicating the vertical face of the brow is visible, as is the fracture at a distance of approximately 80 cm above the back at the brow face. The radar indicates that the fracture is inclined relative to the back. However, this could not be verified, as no test hole was available at this location.

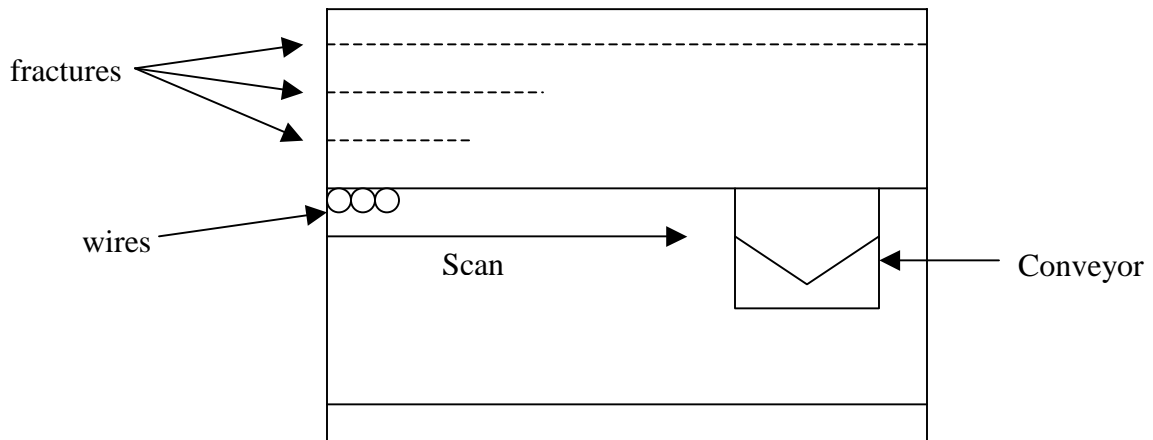
Figure 9: Cross-section of 13 conveyor drift showing approximate locations of fractures.

A second test site, along the 13 Conveyor Drift, was selected to demonstrate the ability of CRIS to identify multiple fractures. This time the scan was performed across the width of the drift as illustrated in Figure 9. Visual inspection of the brow indicated three fractures at heights of 30 cm, 83 cm and 130 cm (Figure 10 and Figure 5). The first two were not continuous across the width of the scan area.

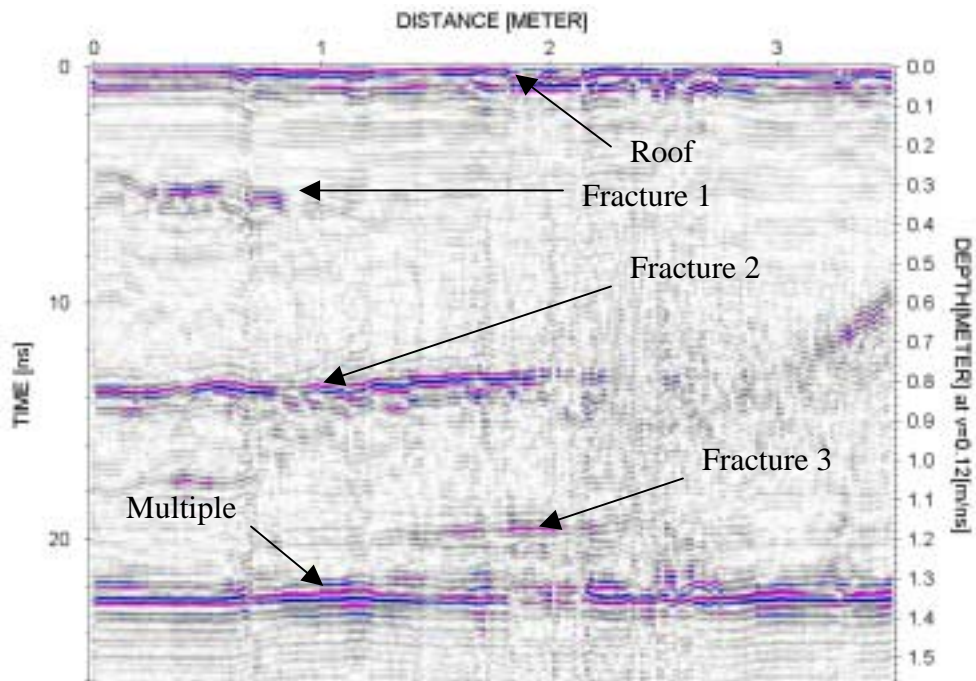
Figure 11: Cross-sectional profile of brow in 13 Conveyor Drift showing location of fractures.

Figure 11 is the radargram obtained from the survey. Notice that the two uppermost fractures do not span the entire width of the scan (visually confirmed). A multiple in the radargram occurs just below the lowermost fracture. This feature was inherent to the CRIS GPR as configured. New potash specific versions of the GPR hardware have eliminated this artefact.

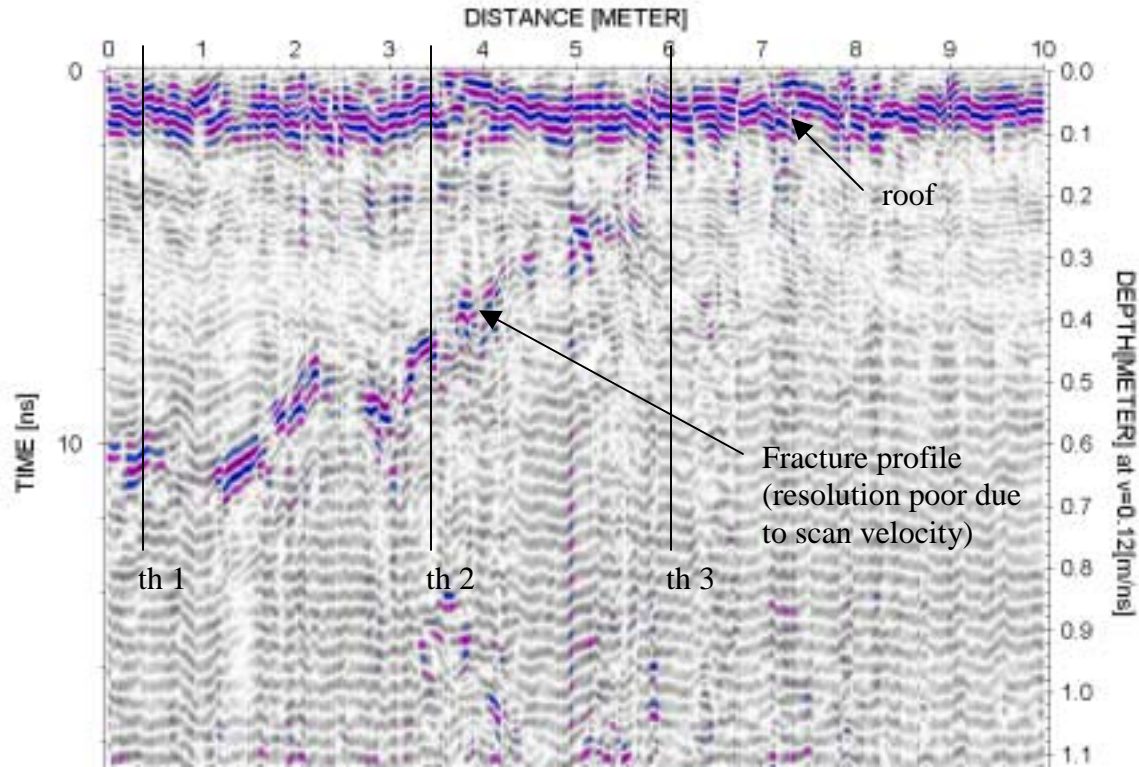
Figure 13: Radar profile along line in the N33W fresh air drift at Allan Mine.

This test site was in close proximity to the active mining face (Figure 12). The crew had just finished bolting this location because they had determined it to be unstable through sounding with a scaling bar. A test hole (th2) was drilled to verify the location of a fracture above the roof (at approximately 47.5 cm above the back, with an aperture of approximately 2.5 cm). This presented an ideal situation in which to use CRIS to detect this fracture. A scan was performed along the diagonal line shown, from the back of a moving jeep. The resulting radar profile is presented in Figure 13. A further two test hole locations (th1 and th3) were proposed to verify the location of the inclined fracture observed using the CRIS radar (i.e. the fracture was predicted to be at a depth of 2 ft (0.61 m) at th1 and just under 1 ft (0.25 m) at th3). Before confirmation could be made, a portion of the back came down at this location. Darrel Wagner, Allan ground control engineer, described the piece that dropped as being wedge shaped (with a shape very similar to what had been predicted using CRIS data). Subsequent drilling at th1 located the fracture at 0.66 m (2 ft 2 inches). The roof failed in this area before th3 could be drilled. The observed shape and location of the fracture surface were in very good agreement with the measurements made using the CRIS radar.

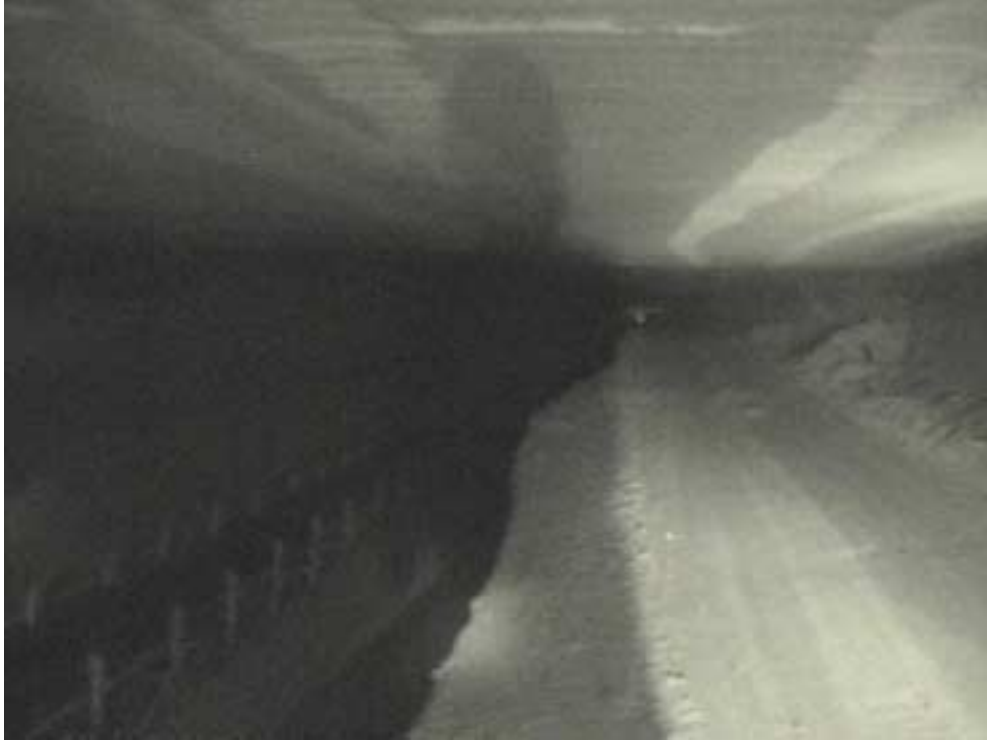
Figure 14: Photo showing geometry of Room C-0253 at the time of the test using the SUSI radar.

At the time of the test, Room C-0253 was actively being mined in the third pass. Figure 14 is a photo showing the geometry of the room at the test location. Scans were performed from the 1700 foot marker to the 1600 foot marker along the upper bench of the room. This location was selected because at the 1670 foot mark (approximately), the shadow band clay seam dipped down and daylighted in the room (Figure 15). The mining crew had previously bolted this area, recognizing the potential for instability.

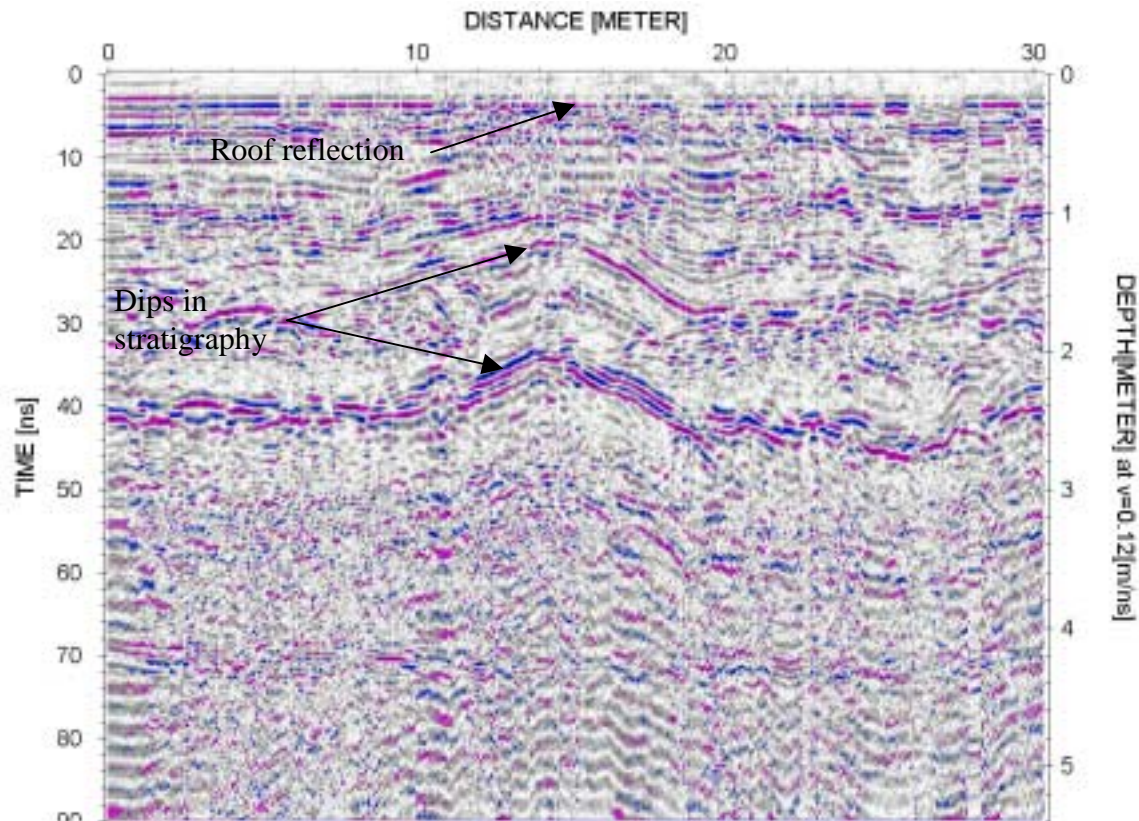
Figure 16: SUSI radargram from Room C-0253 at Lanigan Mine.

The SUSI radar picked up a strong reflection above the roof (Figure 16). The location of this reflection is higher than the expected location of the shadow band. However, the shape of the feature does correspond to the expected shape of the shadow band in this area. There are some other, less intense, shallow reflections but they are difficult to separate from the “ringing” in the radargram. Non-directional dipole antennas were used in this test, thus reflections were picked up from all directions. Subsequent work using ridged horn antennas (not reported herein) has greatly improved the resolution for clay layer mapping.
